# **Lembeh Divers**

## **House Reef Project**

### **Report**

**September/October 2008**

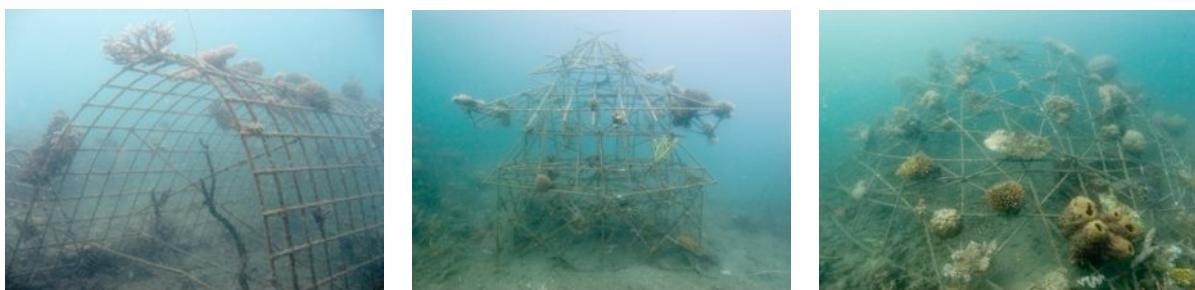
Figure 1: Photographs of the three Biorock installations: tunnel, pagoda, and dome respectively.

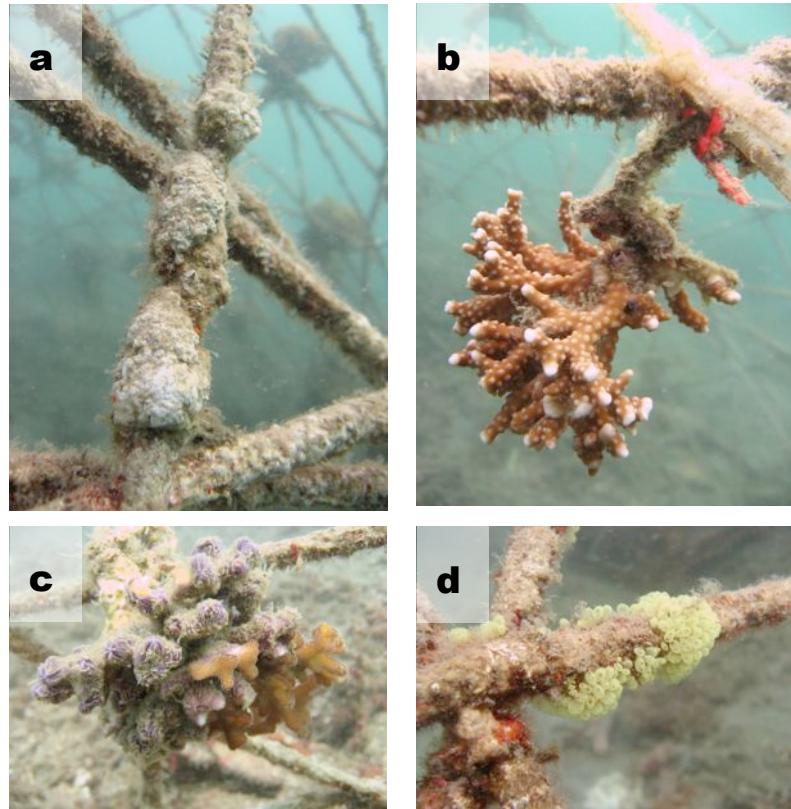
On arrival all three Biorock structures had a significant layer of filamentous algal cover (Figure 2a) over the base layer of calcium carbonate deposit, which was at times being grazed by herbivorous fish species (e.g. parrotfish, surgeonfish), but not sufficiently to prevent the algal build up. Lower parts of each structure had (and will continue to have) coarse grade sediment cover. Assuming that only coral fragments with some remaining living tissue were attached, coral transplant mortality was mostly restricted to partial mortality, although some entirely dead fragments were also found and subsequently removed. A number of naturally settled scleractinian (hard) coral larvae were found on each of the installations, particularly the tunnel. The reasons for this preference of structure are unclear, although being the shallowest of the installations it may allow better access to light for the newly settled corals to gain energy via photosynthesis. While visual identification is difficult, the majority seem to be *Acropora* and *Pocillopora* species. There were small areas of both colonial and encrusting ascidian species and encrusting sponge species, each of which could spread rapidly to out-compete coral transplants. The central pagoda installation appears to have developed increased (and more uneven) mineral deposits compared to the other installations, although the reasons for this are not clear (perhaps shape/complexity or anode positioning). The power supply to the installations on arrival was set at 6V/25A DC, with on/off cycles delivering power between 06:00-16:00, and 19:00-03:00.

**Figure 2:** Close-up photos of Biorock dome installation, showing calcium carbonate accretion on the metal frame (a), algal growth over a dislodged coral fragment (b), encrusting sponge overgrowing a coral fragment (c), and colonial ascidian and algal growth on metal frame (d).

**Biorock** Continued removal of virulent encrusting species of both ascidian and sponge is recommended across all installations (wire brush). For the pagoda, coral transplantation should probably be restricted to the outer parts of the frame, as once the corals grow larger the inside of the structure will become shaded, restricting available light for any centrally located colonies.

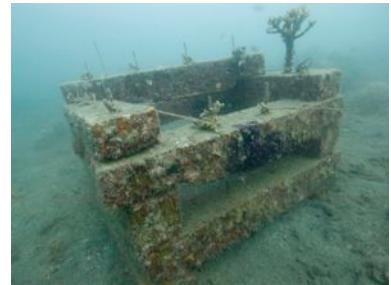
The concrete block installations (aka “fish houses”) are scattered over a large area, from within the Biorock dome, heading North to near the mandarinfish dive site, generally between approximately 7-15m in depth. Some of the installations, particularly the smaller ones, appear unstable and close to toppling. The majority of the installations had a significant layer of coarse sediment cover. Nonetheless there was evidence of some coral settlement, with juvenile colonies starting to become established on some of the blocks. Two of the installations had large quantities of macroalgal growth on them, to the extent that coral larvae settlement would be very unlikely. They are located next to a natural reef area that also has high macroalgal cover, and while there are herbivorous damselfish resident in the area, their actions seem insufficient to maintain the algal growth in check, and these installations are unlikely to attract significant coral growth in their current state. One of the installations has significant coverage of an encrusting ascidian, which appears sufficiently virulent to out-compete at least some of the coral transplants so far.

**Figure 3:** Photo of one of the larger and more stable concrete block installations, showing coral fragment transplants, and various other types of marine growth.

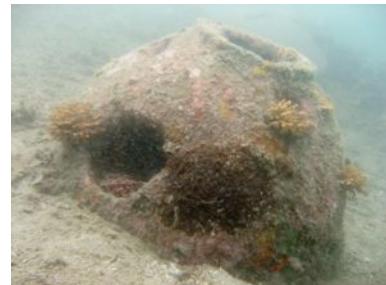
**Figure 4:** Photo of one of the reef-ball installations, showing good growth of *Acropora* corals.

Comparing the reef-balls here to others at a more pristine site located further South at Ratatotok, those on the house reef appear to be working as well as could be expected given length of time they have been in the water, combined with the prevailing environmental conditions. All reef-balls show signs of some coarse sedimentation, but due to their shape this cannot accumulate substantially. Most show signs of some coral settlement, and while growth is comparatively slow compared to similar installations in other areas, this is likely due to water quality affecting the light levels available for photosynthesis. Of the artificial reef installations on the house reef, these currently seem to be providing the greatest benefit.

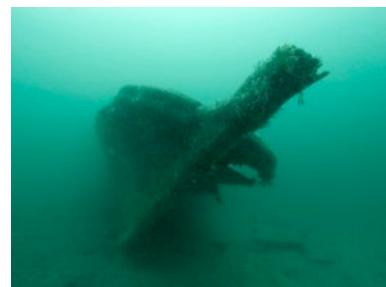
A small boat (~12m long) has been sunk onto the sand substrate in approximately 26m depth. The wreck has not been in place long enough to develop any substantial marine growth, although there is evidence of some small wood-boring organisms, some limited coral and bryozoan settlement, and both filamentous algal cover and sediment cover. Small shoals of sweetlips (*Plectorhinchus* sp.) aggregate close to the wreck, along with small numbers of batfish (*Platax* sp.), a few small pufferfish (*Canthigaster valentini*), etc. Two “squid lines” are in place just off each end of the wreck, with the aim to have squid lay eggs on them. Currently there is no indication of any squid activity, but they show the expected levels of marine growth, including algae, sponge, ascidian, and bryozoan activity. Given the depth of the wreck, the levels of growth are entirely as expected, and it is recommended to simply leave it as it stands.

**Figure 5:** Photo of the wreck in the deeper waters of the house reef.

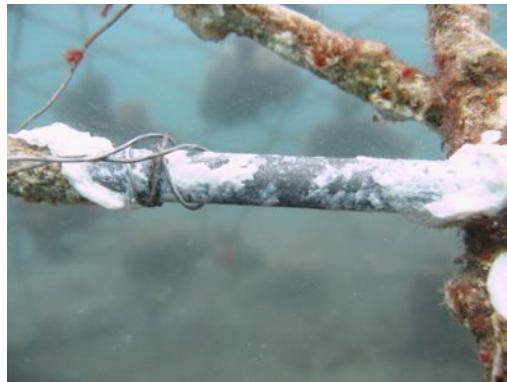
**Figure 1:** Close-up photo of Biorock, showing where a dead coral fragment has been removed. Such a site is a good choice for a new transplant to be made, as calcium carbonate deposition (and therefore coral attachment) will be fast on the metal. Notice that the wire used to attach the coral fragment is touching the bare metal.

All transplants should be attached to well-cleaned Biorock substrate, with healthy live tissue held securely against either the metallic surface or to algae-free calcified deposit. Attachment site should be thoroughly cleaned/checkered before attachment, and must be made securely enough that the coral fragment will not move around in the water current, as insecure attachment is known to increase fragment mortality (Bowden-Kerby, 2001). When a coral transplant has died and needs to be removed, the removal of the old transplant can sometimes pull away calcified deposits down to the metal base. As this metal base is likely to provide the fastest site of new CaCO<sub>3</sub> deposits, it is recommended to use this as a site for a new transplant while the metal is still bare (Figure 1).
