# **Lembah Divers House Reef Project Report**

**September/October 2008**

**Giles Winstanley**

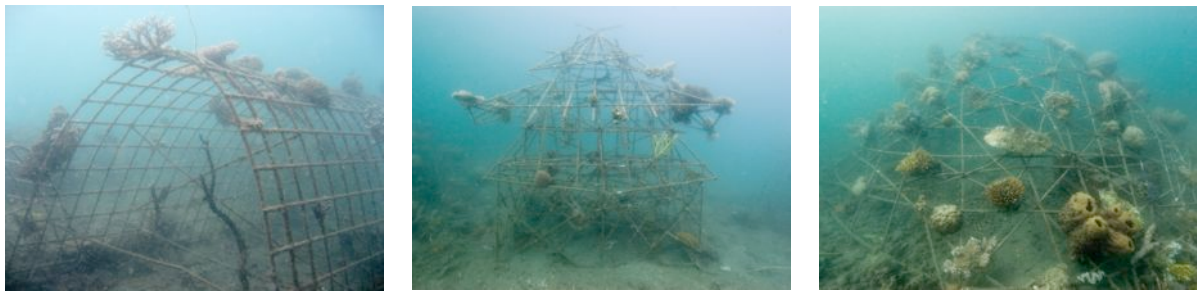
**Figure 1: Photographs of the three Biorock installations: tunnel, pagoda, and dome respectively.**

On arrival all three Biorock structures had a significant layer of filamentous algal cover (Figure 2a) over the base layer of calcium carbonate deposit, which was at times being grazed by herbivorous fish species (e.g. parrotfish, surgeonfish), but not sufficiently to prevent the algal build up. Lower parts of each structure had (and will continue to have) coarse grade sediment cover. Assuming that only coral fragments with some remaining living tissue were attached, coral transplant mortality was mostly restricted to partial mortality, although some entirely dead fragments were also found and subsequently removed. A number of naturally settled scleractinian (hard) coral larvae were found on each of the installations, particularly the tunnel. The reasons for this preference of structure are unclear, although being the shallowest of the installations it may allow better access to light for the newly settled corals to gain energy via photosynthesis. While visual identification is difficult, the majority seem to be *Acropora* and *Pocillopora* species. There were small areas of both colonial and encrusting ascidian species and encrusting sponge species, each of which could spread rapidly to out-compete coral transplants. The central pagoda installation appears to have developed increased (and more uneven) mineral deposits compared to the other installations, although the reasons for this are not clear (perhaps shape/complexity or anode positioning). The power supply to the installations on arrival was set at 6V/25A DC, with on/off cycles delivering power between 06:00-16:00, and 19:00-03:00.

**Biorock** Continued removal of virulent encrusting species of both ascidian and sponge is recommended across all installations (wire brush). For the pagoda, coral transplantation should probably be restricted to the outer parts of the frame, as once the corals grow larger the inside of the structure will become shaded, restricting available light for any centrally located colonies.

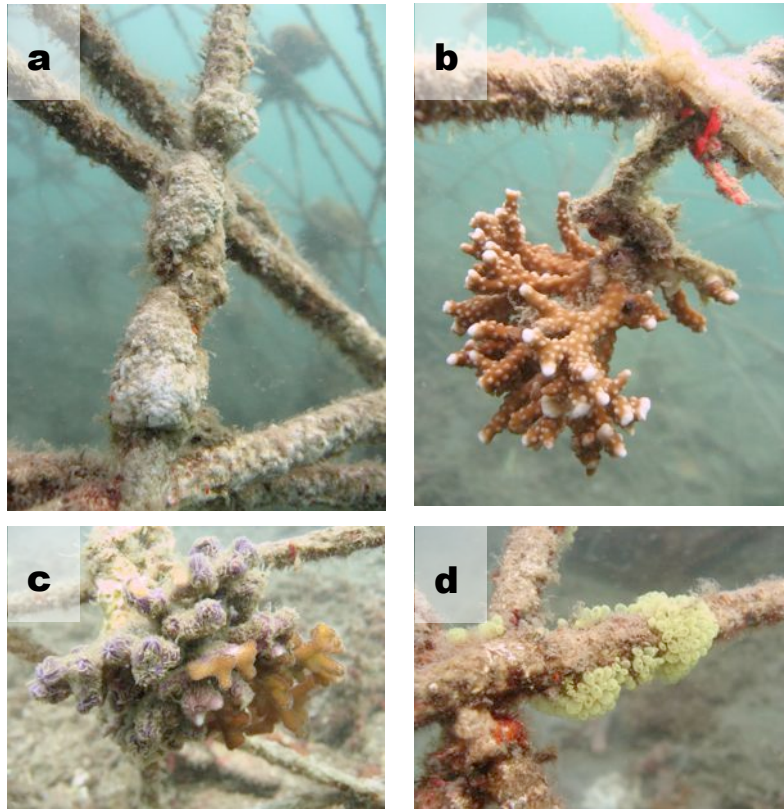
**Figure 2: Close-up photos of Biorock dome installation, showing calcium carbonate accretion on the metal frame (a), algal growth over a dislodged coral fragment (b), encrusting sponge overgrowing a coral fragment (c), and colonial ascidian and algal growth on metal frame (d).**

Routine Biorock maintenance performed includes widespread removal of potentially problematic algal growth over all three installations, and removal of problematic ascidian/sponge growth which could out-compete coral transplants. Dead colonies found on each installation were removed, and some of the current transplants were re-transplanted to provide more stable attachment. Several new transplants were performed, including several of massive *Porites* sp. to increase reef-building coral numbers.

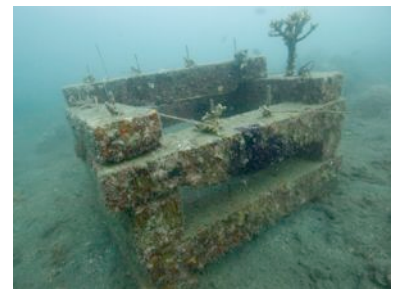
The concrete block installations (aka “fish houses”) are scattered over a large area, from within the Biorock dome, heading North to near the mandarinfish dive site, generally between approximately 7-15m in depth. Some of the installations, particularly the smaller ones, appear unstable and close to toppling. The majority of the installations had a significant layer of coarse sediment cover. Nonetheless there was evidence of some coral settlement, with juvenile colonies starting to become established on some of the blocks. Two of the installations had large quantities of macroalgal growth on them, to the extent that coral larvae settlement would be very unlikely. They are located next to a natural reef area that also has high macroalgal cover, and while there are herbivorous damselfish resident in the area, their actions seem insufficient to maintain the algal growth in check, and these installations are unlikely to attract significant coral growth in their current state. One of the installations has significant coverage of an encrusting ascidian, which appears sufficiently virulent to out-compete at least some of the coral transplants so far.

**Figure 3: Photo of one of the larger and more stable concrete block installations, showing coral fragment transplants, and various other types of marine growth.**

In general, the taller an artificial reef structure is above the substrate the less it is affected by coarse grade sedimentation such as stirred up sand, and as a result the taller of the concrete block structures are those most likely to give good results in the long term. Many of the smaller installations are either unstable or small enough to be highly effected by such sedimentation, and would likely benefit from redesign or replacement. One way might be to consolidate the materials from more than one installation to construct a new, bigger installation. Care should be taken to minimise the likelihood of instability/toppling due to water motion.

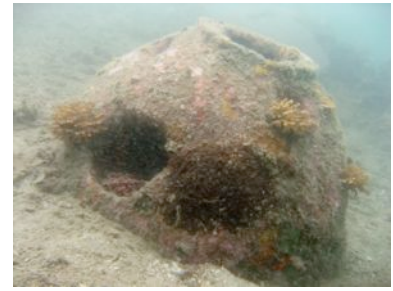
**Figure 4: Photo of one of the reef-ball installations, showing good growth of *Acropora* corals.**

Comparing the reef-balls here to others at a more pristine site located further South at Ratatotok, those on the house reef appear to be working as well as could be expected given length of time they have been in the water, combined with the prevailing environmental conditions. All reef-balls show signs of some coarse sedimentation, but due to their shape this cannot accumulate substantially. Most show signs of some coral settlement, and while growth is comparatively slow compared to similar installations in other areas, this is likely due to water quality affecting the light levels available for photosynthesis. Of the artificial reef installations on the house reef, these currently seem to be providing the greatest benefit.

As with the concrete blocks, the reef-balls are subject to some coarse grade sedimentation as they are positioned on a sandy slope where silt from higher up the slope can be deposited on them. However, due to their rounded shape and the fact that the reef-balls are generally higher off the substrate than the majority of the concrete block installations, they are less affected by it. Currently the reef-balls are probably the best performing, or at least most reliably performing, of the artificial reef structures, and the best course of action for them is simply to leave them as they are.

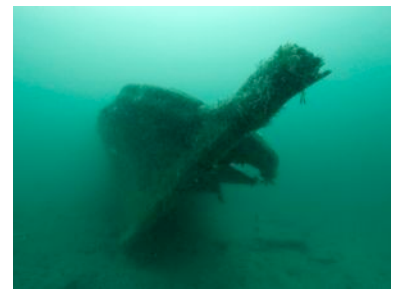
A small boat (~12m long) has been sunk onto the sand substrate in approximately 26m depth. The wreck has not been in place long enough to develop any substantial marine growth, although there is evidence of some small wood-boring organisms, some limited coral and bryozoan settlement, and both filamentous algal cover and sediment cover. Small shoals of sweetlips (*Plectorhincus* sp.) aggregate close to the wreck, along with small numbers of batfish (*Platax* sp.), a few small pufferfish (*Canthigaster valentini*), etc. Two “squid lines” are in place just off each end of the wreck, with the aim to have squid lay eggs on them. Currently there is no indication of any squid activity, but they show the expected levels of marine growth, including algae, sponge, ascidian, and bryozoan activity. Given the depth of the wreck, the levels of growth are entirely as expected, and it is recommended to simply leave it as it stands.

**Figure 5: Photo of the wreck in the deeper waters of the house reef.**

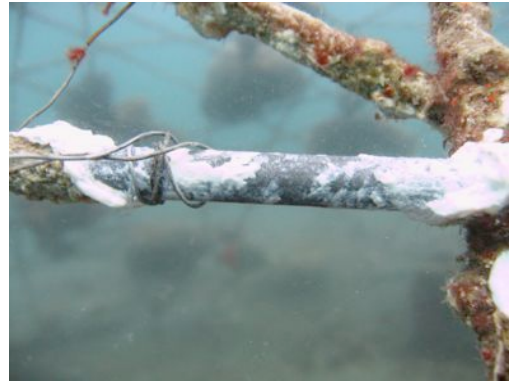
**Figure 1: Close-up photo of Biorock, showing where a dead coral fragment has been removed. Such a site is a good choice for a new transplant to be made, as calcium carbonate deposition (and therefore coral attachment) will be fast on the metal. Notice that the wire used to attach the coral fragment is touching the bare metal.**

All transplants should be attached to well-cleaned Biorock substrate, with healthy live tissue held securely against either the metallic surface or to algae-free calcified deposit. Attachment site should be thoroughly cleaned/checked before attachment, and must be made securely enough that the coral fragment will not move around in the water current, as insecure attachment is known to increase fragment mortality (Bowden-Kerby, 2001). When a coral transplant has died and needs to be removed, the removal of the old transplant can sometimes pull away calcified deposits down to the metal base. As this metal base is likely to provide the fastest site of new  $\text{CaCO}_3$  deposits, it is recommended to use this as a site for a new transplant while the metal is still bare (Figure 1).
