Lembeh Resort House Reef Project July 2009  
Katerina Bengtsson Kupcik  
flamboyant.kat@gmail.com

**House reef project status report 2009**

This is a write-up of observations of the house reef project based on dives conducted 21-26 July 2009. This is a comparative study to our previous work on the House reef (HSR) during November 2006-April 2008.

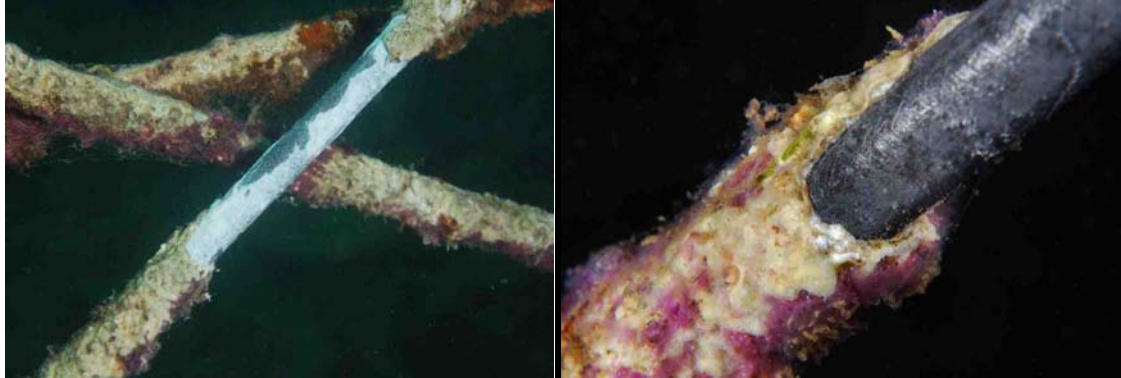
**Fig 1, 2:** Calcification on the Blob

The layer of the CaCO<sub>3</sub> on the Biorock is very thin (Fig 1, 2), given the time it had to accumulate from the water column. The expected CaCO<sub>3</sub> thickness should be significantly higher. There could be several reasons for that:

1. There are 3 medium sized Biorocks connected to one another and 4 medium sized anodes. For additional anodes (titanium mesh) is the best to contact Tom Goreau [communications@biorock.net](mailto:communications@biorock.net). Two of the anodes, close to the blob were moved approximately 1.5m closer to the structure in July 2009. The remaining two anodes can be also moved closer to the Biorocks if there is any effect seen from this. The amount of bubbles should be greater when the anodes are closer, hence when there is more current.

2. The shallow sloping topography of the House Reef did not allow us to create these Biorocks closer to their power source. The Biorocks lie about 120m away from the source, which is on the edge of electric current reaching them.

3. The maximum cable diameter available in Manado when the Biorocks were constructed was 3.5mm, which might not be optimal. Thicker cables would increase the amount of electricity reaching the Biorocks.

4. There is a need for a new battery charger. The battery charger needs to have an energy output set for 12 volts with the outgoing current between 25- 30 amperes. The old battery charger had the 12 volt output missing.

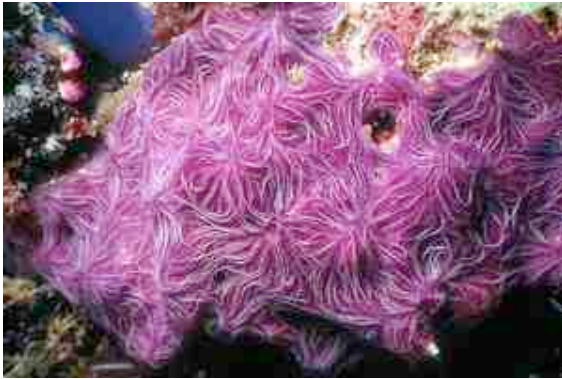
**Fig 3:** *Chalinula nematifera* (Webb)

There is a need of a regular (monthly) removal of the purple coloured sponge, *Chalinula nematifera* (Fig. 2, 3). *C. Nematifera* is a coral eating sponge and a fast grower, therefore it is a tough competitor for anything else to settle on to the Biorocks.

The coral eating sponge (*C. Nematifera*) (Fig 3, 4) probably settled onto the Biorocks from the water column but was also possibly transported onto the Biorocks with the transplanted coral colonies. When we initially transplanted the corals, we targeted coral colonies which were in some kind of stress (sedimentation, competition, or infected by this coral eating sponge). The colonies, which were infected by coral eating sponge, were cleaned of it, but some remnants might have remained inside the coral colonies. This then spread once again onto the corals and onto the structures. The corals on the structure will most likely die if the sponge is not being constantly removed (Fig:5). This might be a local Lembeh problem, but there is a lot of this particular coral eating sponge around. The sponge settles easily on calcium carbonate surface and therefore settles so readily on the Biorock structures, which have a perfect clean layer of  $\text{CaCO}_3$ .

It had been written that the sponge *C. nematifera* settles mainly on massive corals (i.e. Porites), because it needs sufficient light for the cyanobacteria living inside it to photosynthesise. This is not so in the Lembeh HSR. It also seems to settle quite readily on branching corals. In any case it has been classified as a future possible stressing factor and maybe even threat to coral reefs, (as if there are not enough of those already) and it should be monitored as it might pose a bigger problem than killing the corals on the Biorocks in the future.

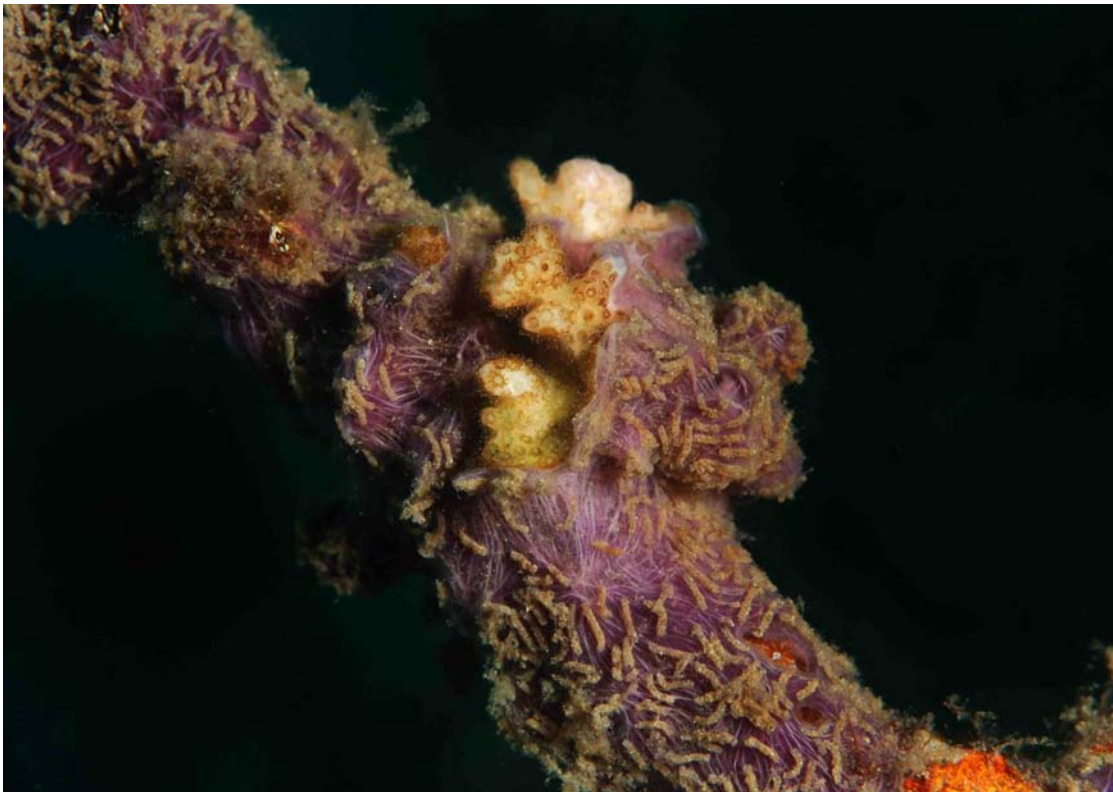
**Fig 5:** *Pocillopora* sp. Attacked by *C. nematifera* on the Blob.

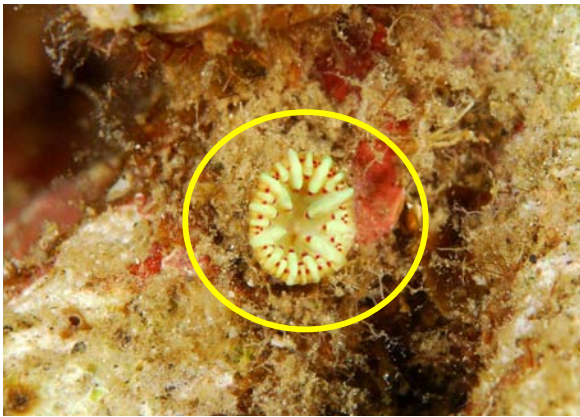
Competition for space poses one of the biggest threats to the newly settled coral spats. Coral spats are a single coral larvae settling naturally from the water column. This coral spat continues to grow into a single polyp (smallest building block of a coral colony; Fig 6). This single polyp will then through rather slow growth lay a skeleton of  $\text{CaCO}_3$  and then via asexual reproduction called budding, which is in fact everlasting repetition of itself, create coral colony of various morphology and size, depending on the coral species and surrounding conditions (Fig 7).

**Fig 6:** Coral polyp

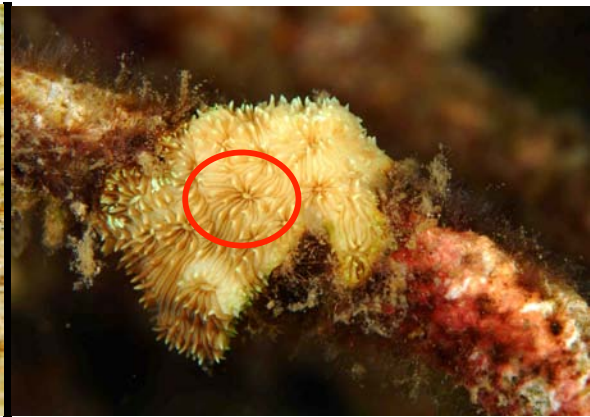
**Fig 7:** Coral polyp in a small coral colony

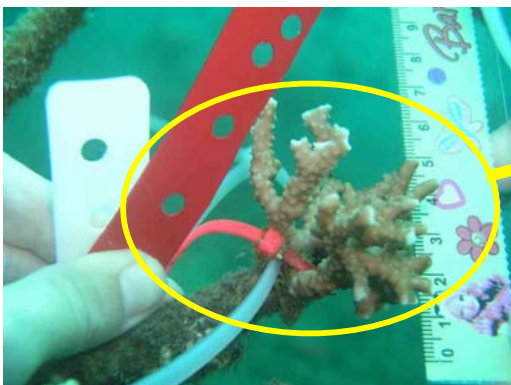
**Fig 8:** Olga's transplanting Oct.08

The suggestion is to not transplant any more coral onto the structure. The only possible exception would be a colony or a part of colony (quite large) which is in danger of either becoming smothered by sand or otherwise threatened. There is definitely NO REASON to transplant tiny coral fragments onto the Biorock! As stated in previous write ups, small coral colonies have a very small probability of survival and they will most probably, in the conditions of the house reef, die (Fig 8, 9). The reason for that is not only the small size of the colonies but also the added stress factor of high sedimentation due to run off on the house reef. It has been tried and did not work!

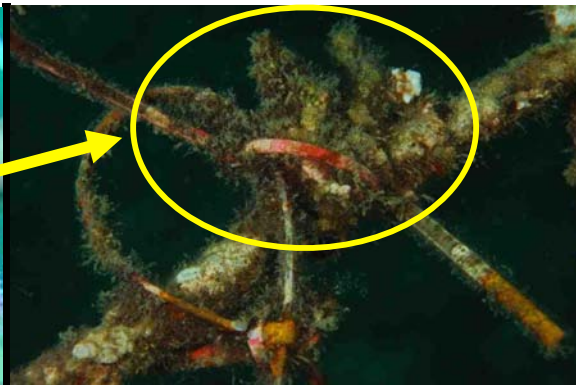
**Fig 9:** Olga's transplanting July 2009
